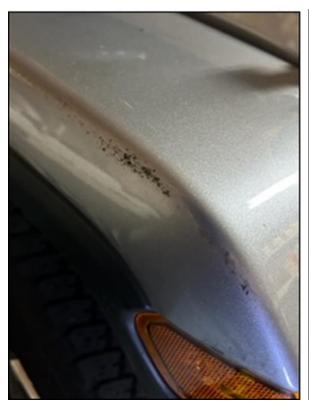
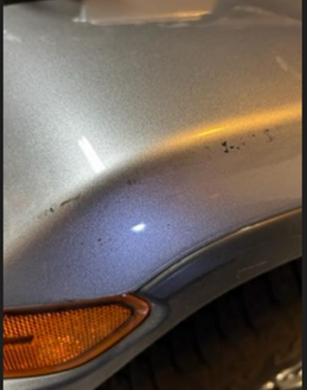
BODY PAINT DAMAGE CAUSED BY FLUTTERING/LOOSE FITTING COVER...
